# Draft Final Stream Mitigation Plan

Long Branch Stream Mitigation Site

**PERMITTEE:** South Carolina Department of Transportation

The LPA Group Incorporated  
A Unit of Michael Baker Corporation  
700 Huger Street  
Columbia, SC 29201

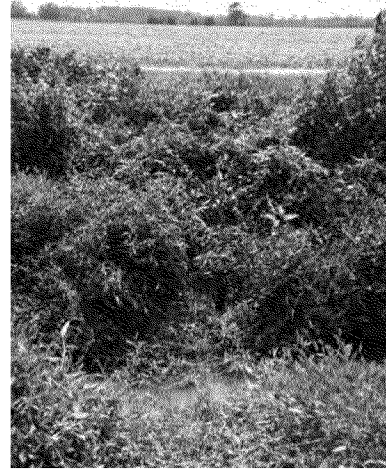
### Cross-section #1

Looking at the Left Bank

Looking at the Right Bank

Feature	Stream Type	BKF Area	BKF Width	BKF Depth	Max BKF Depth	W/D	BH Ratio	ER	BKF Elev	TOB Elev
Rifle	Bc	6.8	7.91	0.86	1.52	9.16	3	1.9	94.8	97.91

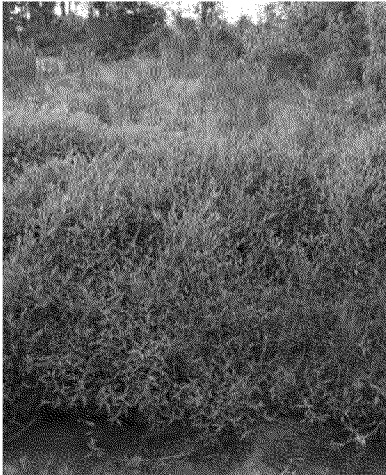
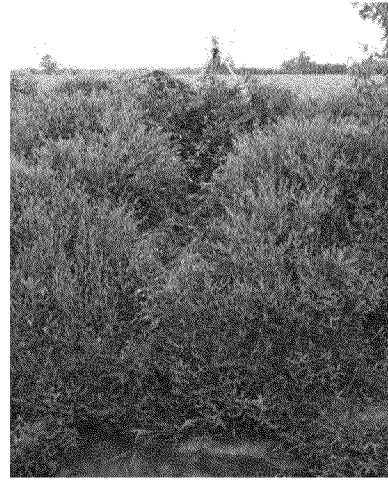
**Cross-section #2**  
(collected June 2011)

Looking at the Left Bank

Looking at the Right Bank

Feature	Stream Type	BKF Area	BKF Width	BKF Depth	Max BKF Depth	W/D	BH Ratio	ER	BKF Elev	TOB Elev
Rifle	G	6	7.62	0.79	1.44	9.68	3.1	1.6	93.6	96.67

**Long Branch Cross-section #2**

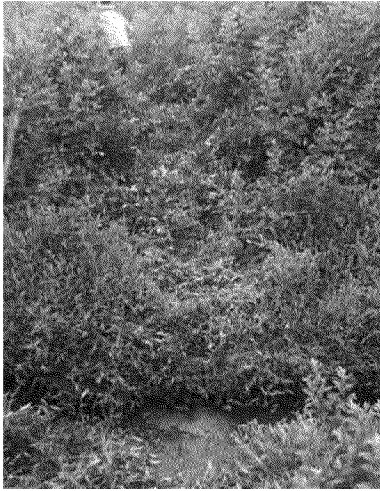
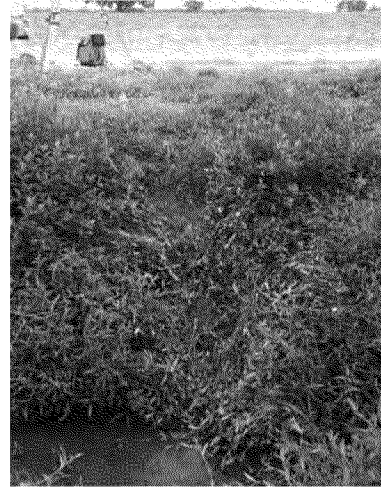
**Cross-section #3**  
(collected June 2011)

Looking at the Left Bank

Looking at the Right Bank

Feature	Stream Type	BKF Area	BKF Width	BKF Depth	Max BKF Depth	W/D	BH Ratio	ER	BKF Elev	TOB Elev
Riffle	Bc	4.7	6.31	0.74	1.61	8.51	3.3	2.1	92.8	96.53

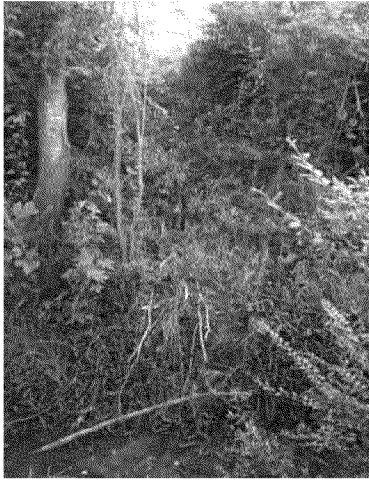
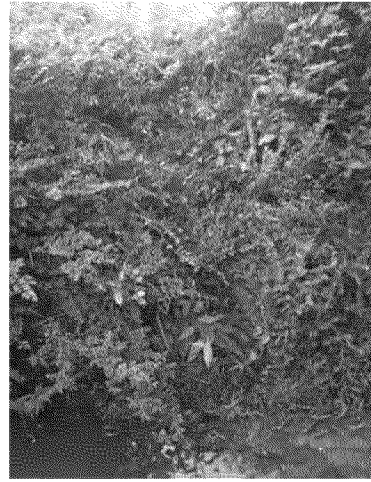
**Cross-section #4**  
(collected June 2011)

Looking at the Left Bank

Looking at the Right Bank

Feature	Stream Type	BKF Area	BKF Width	BKF Depth	Max BKF Depth	W/D	BH Ratio	ER	BKF Elev	TOB Elev
Riffle	Bc	11.2	10.02	1.12	1.94	8.95	2.9	2.1	92.9	96.6

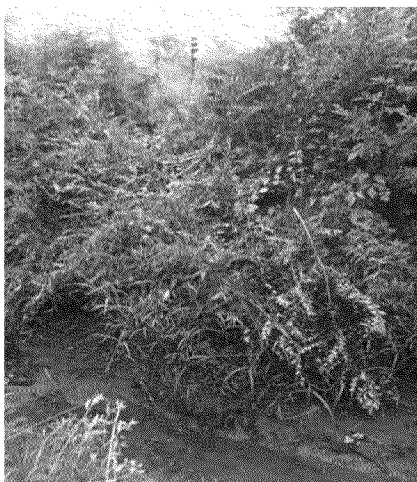
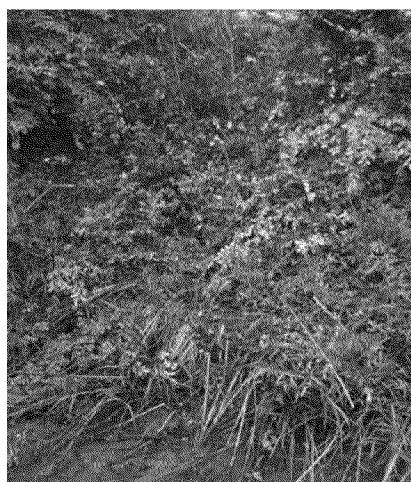
### Cross-section #5

Looking at the Left Bank

Looking at the Right Bank

Feature	Stream Type	BKF Area	BKF Width	BKF Depth	Max BKF Depth	W/D	BH Ratio	ER	BKF Elev	TOB Elev
Riffle	Bc	8.5	8.39	1.01	2.22	8.32	2.5	2	91.5	94.91

### Long Branch Cross-section #5

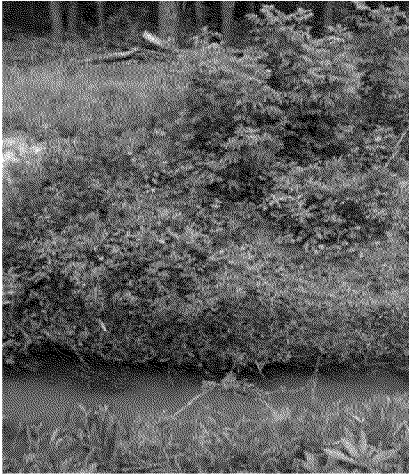
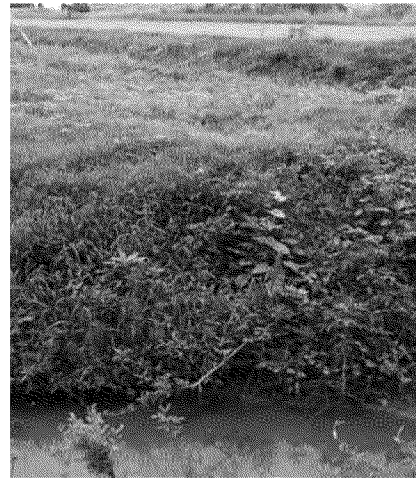
**Cross-section #6**  
(collected June 2011)

Looking at the Left Bank

Looking at the Right Bank

Feature	Stream Type	BKF Area	BKF Width	BKF Depth	Max BKF Depth	W/D	BH Ratio	ER	BKF Elev	TOB Elev
Riffle	E	9.2	5.49	1.67	2.38	3.28	2.2	2.7	90.7	93.61

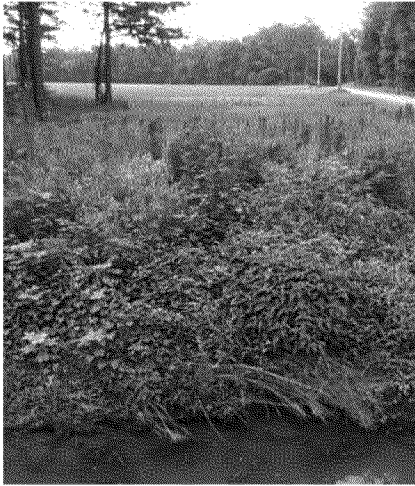
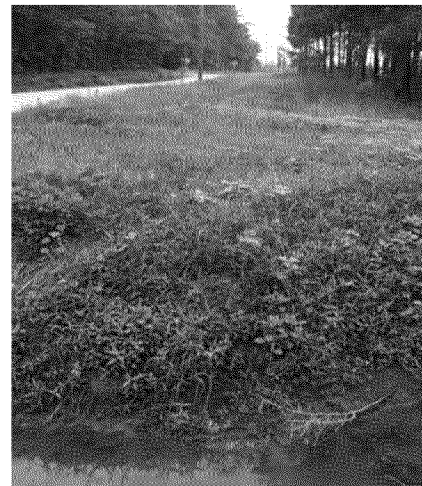
**Cross-section #7**  
(collected June 2011)

Looking at the Left Bank

Looking at the Right Bank

Feature	Stream Type	BKF Area	BKF Width	BKF Depth	Max BKF Depth	W/D	BH Ratio	ER	BKF Elev	TOB Elev
Riffle	G	6.8	7.38	0.92	1.45	8.05	3.3	1.4	89.7	93.01

**Long Branch Cross-section #7**

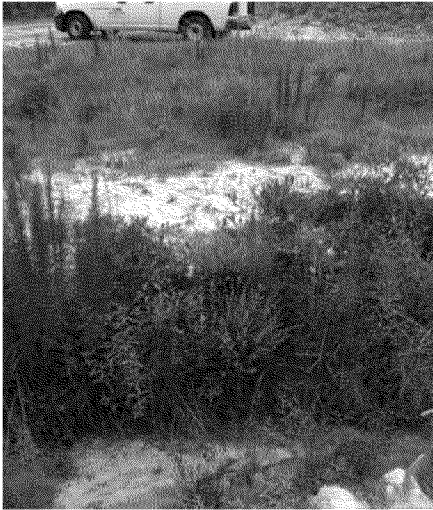
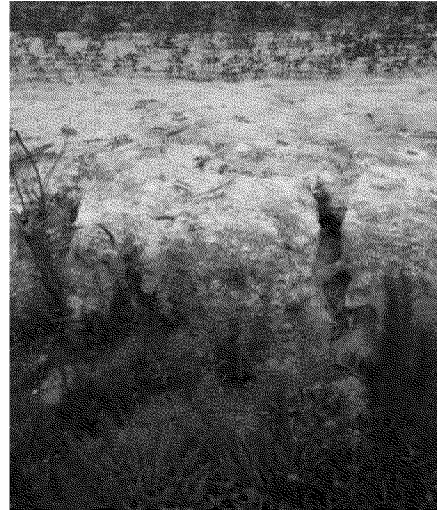
### Cross-section #8

Looking at the Left Bank

Looking at the Right Bank

Feature	Stream Type	BKF Area	BKF Width	BKF Depth	Max BKF Depth	W/D	BH Ratio	ER	BKF Elev	TOB Elev
Rifle	F	1.1	3.64	0.3	0.47	12.29	5.4	1.2	97.6	99.65

### Long Branch UT 1 Cross-section #8

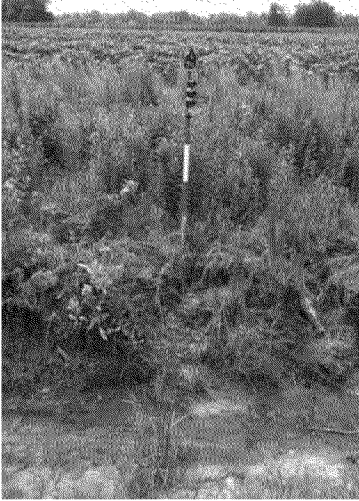
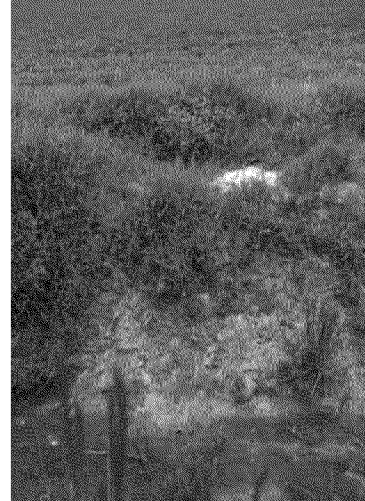
**Cross-section #9**  
(collected June 2011)

Looking at the Left Bank

Looking at the Right Bank

Feature	Stream Type	BKF Area	BKF Width	BKF Depth	Max BKF Depth	W/D	BH Ratio	ER	BKF Elev	TOB Elev
Rifle	F	1	3.92	0.26	0.39	15.05	6.4	1.2	96.48	98.6

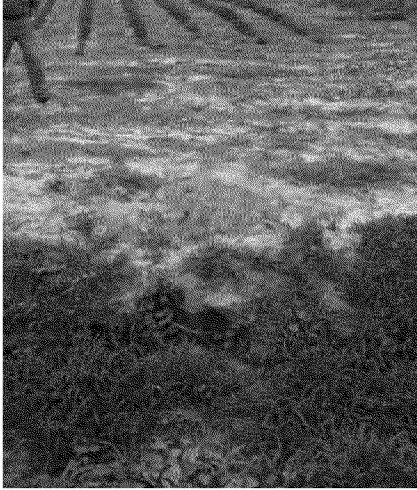
# **Cross-section #10**

( collected June 2011)

Looking at the Left Bank

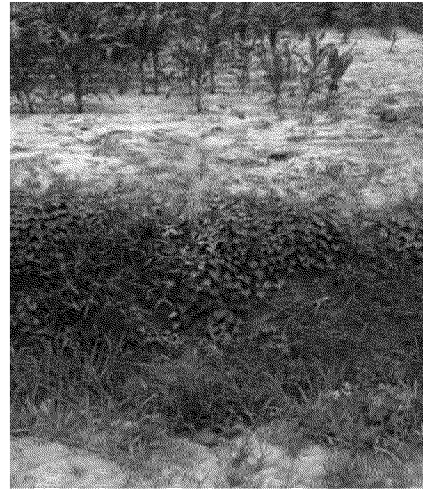
Looking at the Right Bank

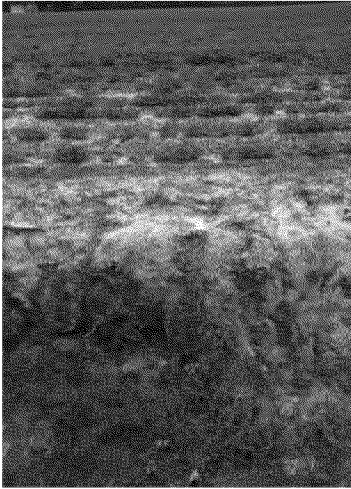
**Cross-section #11**  
(collected June 2011)

Looking at the Left Bank

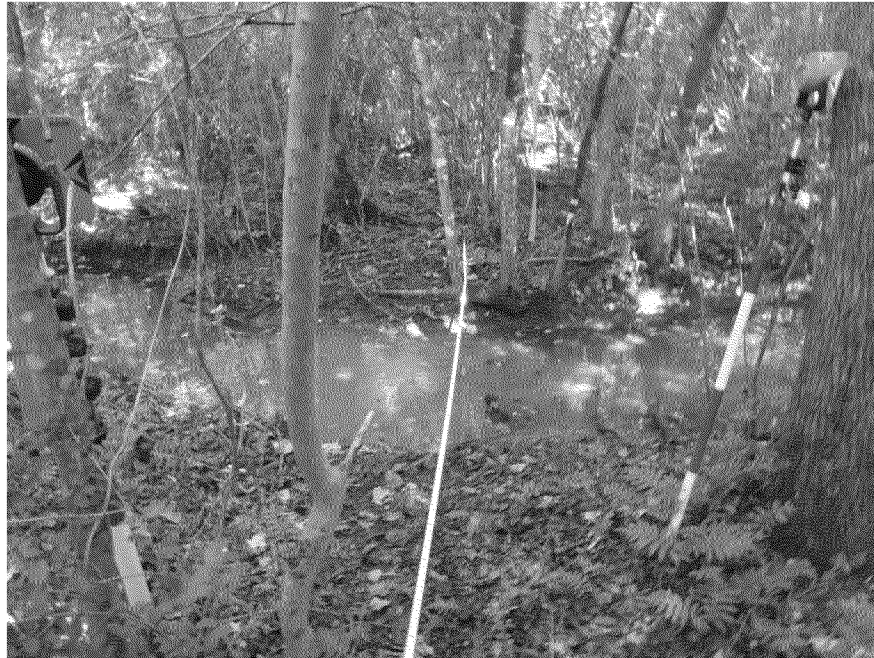
Indian Pot Branch, Section I

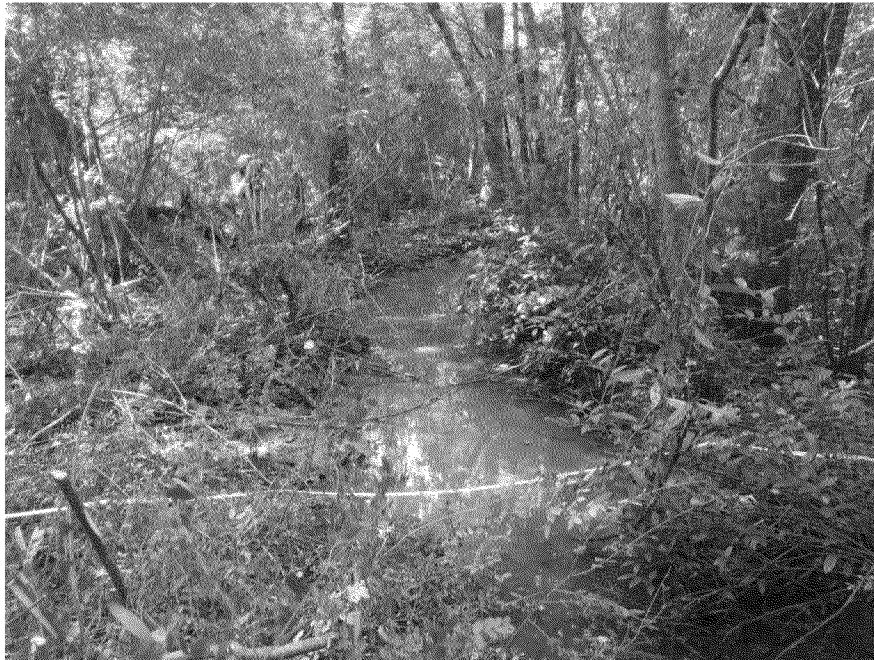
Indian Pot Branch, Section I

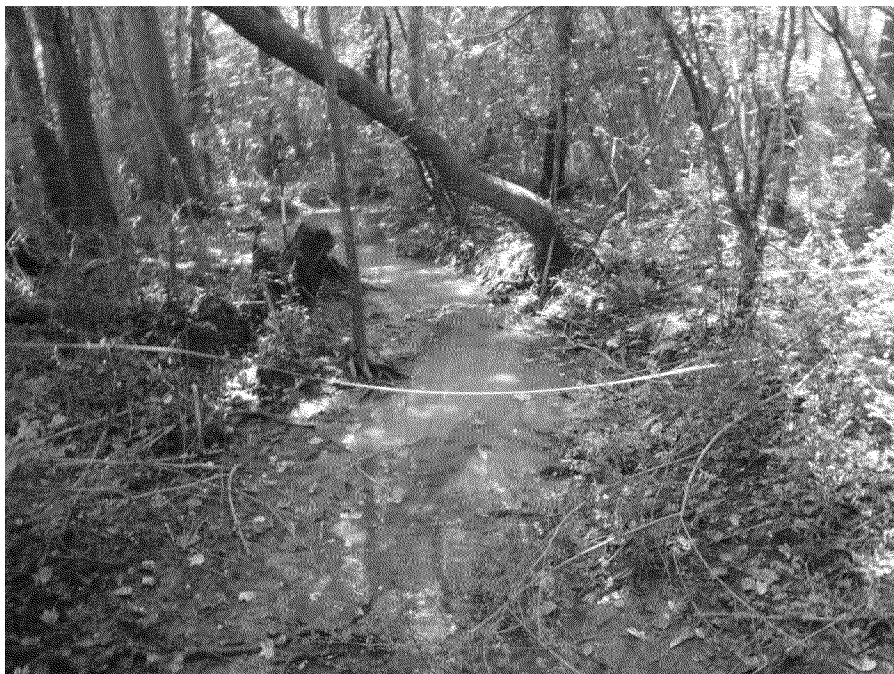
Indian Pot Branch, Section I

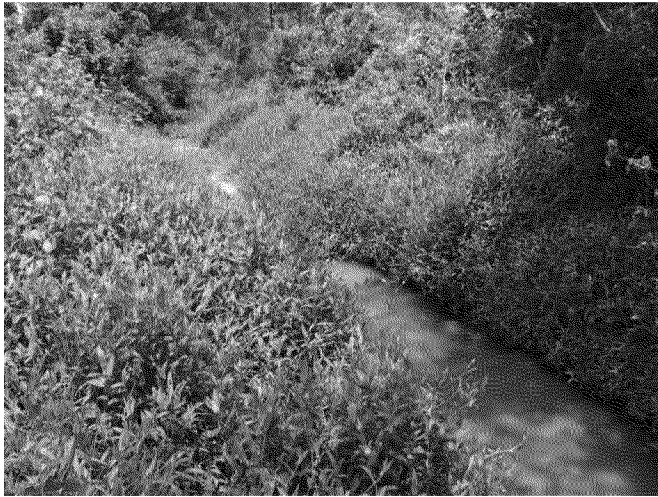
Long Branch, Section A, looking upstream

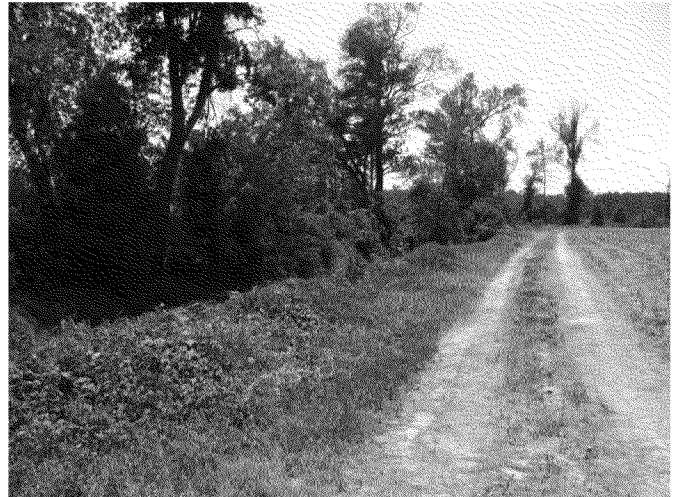
Long Branch, Section A, looking downstream on adjacent farm road

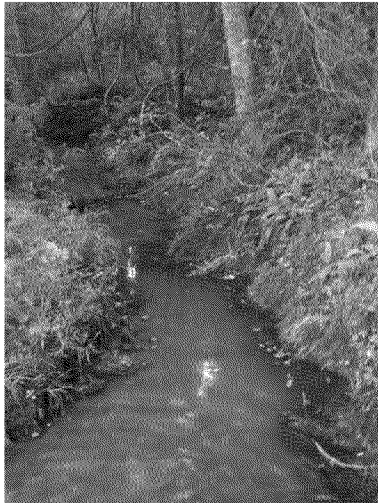
Long Branch, Section C, south of Stubbs Drive

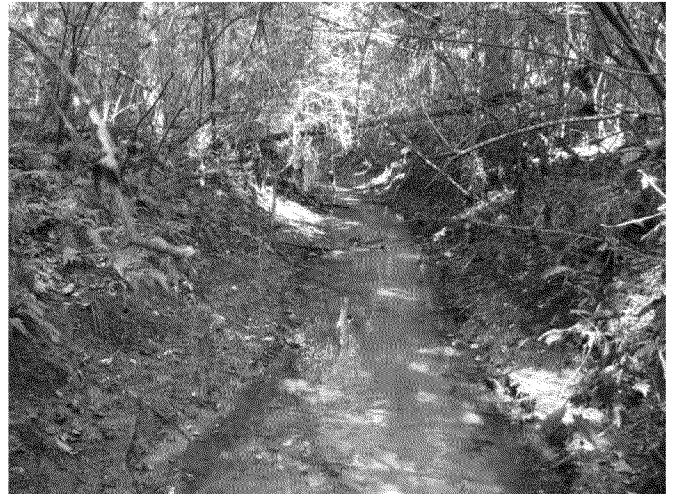
Long Branch, Section C, just south of Bermuda Road

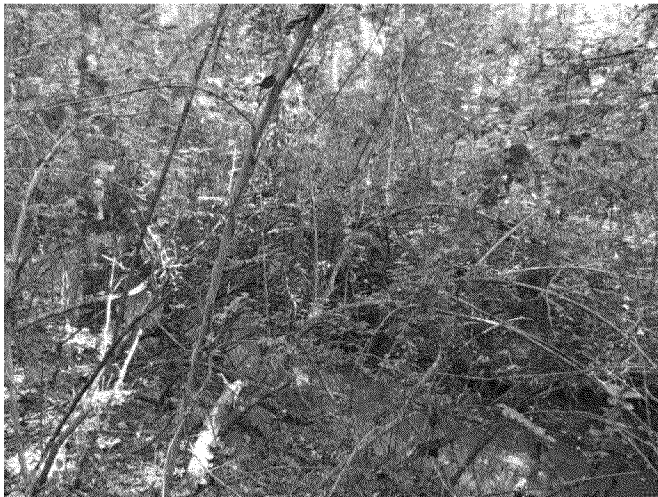
Long Branch, Section C, south of Bermuda Road.  
Note privet on the top of bank

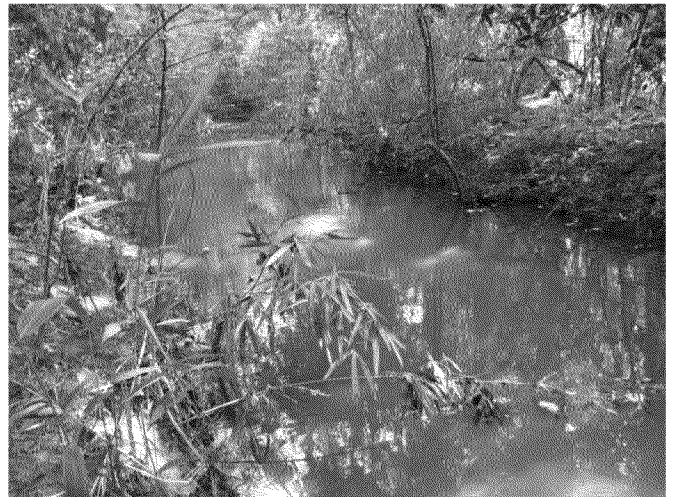
Long Branch, lower portion of Section C

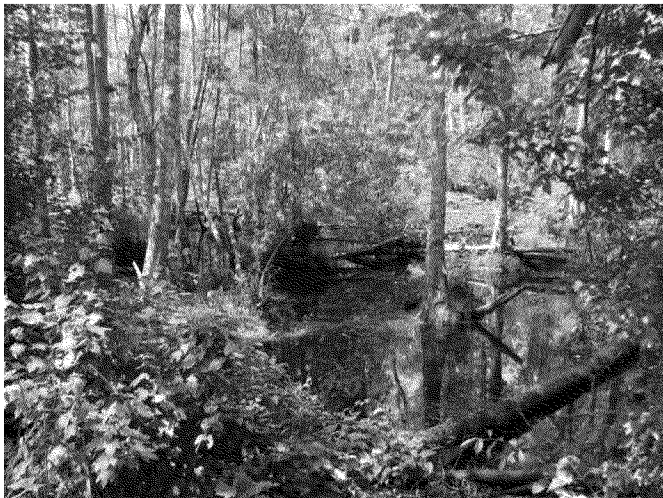
Indian Pot Branch, Section F, wetlands adjacent to Indian Pot Branch

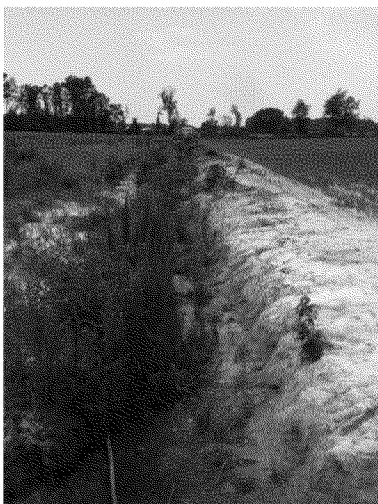
UT1, Section G, looking downstream towards confluence with Long Branch

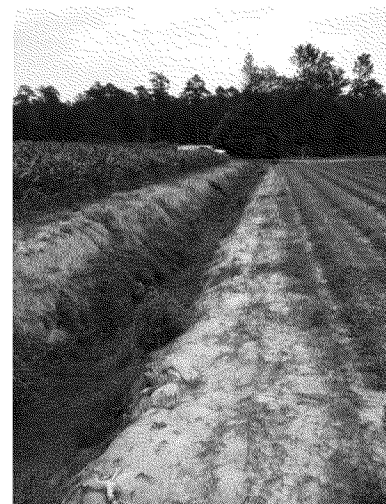
UT2, Section H, looking upstream
